SITE INVESTIGATIONS
FOR RESIDENTIAL DEVELOPMENT
ON THE PORT HILLS,
CHRISTCHURCH

A thesis
submitted in partial fulfilment
of the requirements for the Degree
of
Master of Science in Engineering Geology
in the
University of Canterbury
by
Barry J. McDowell

University of Canterbury
1989

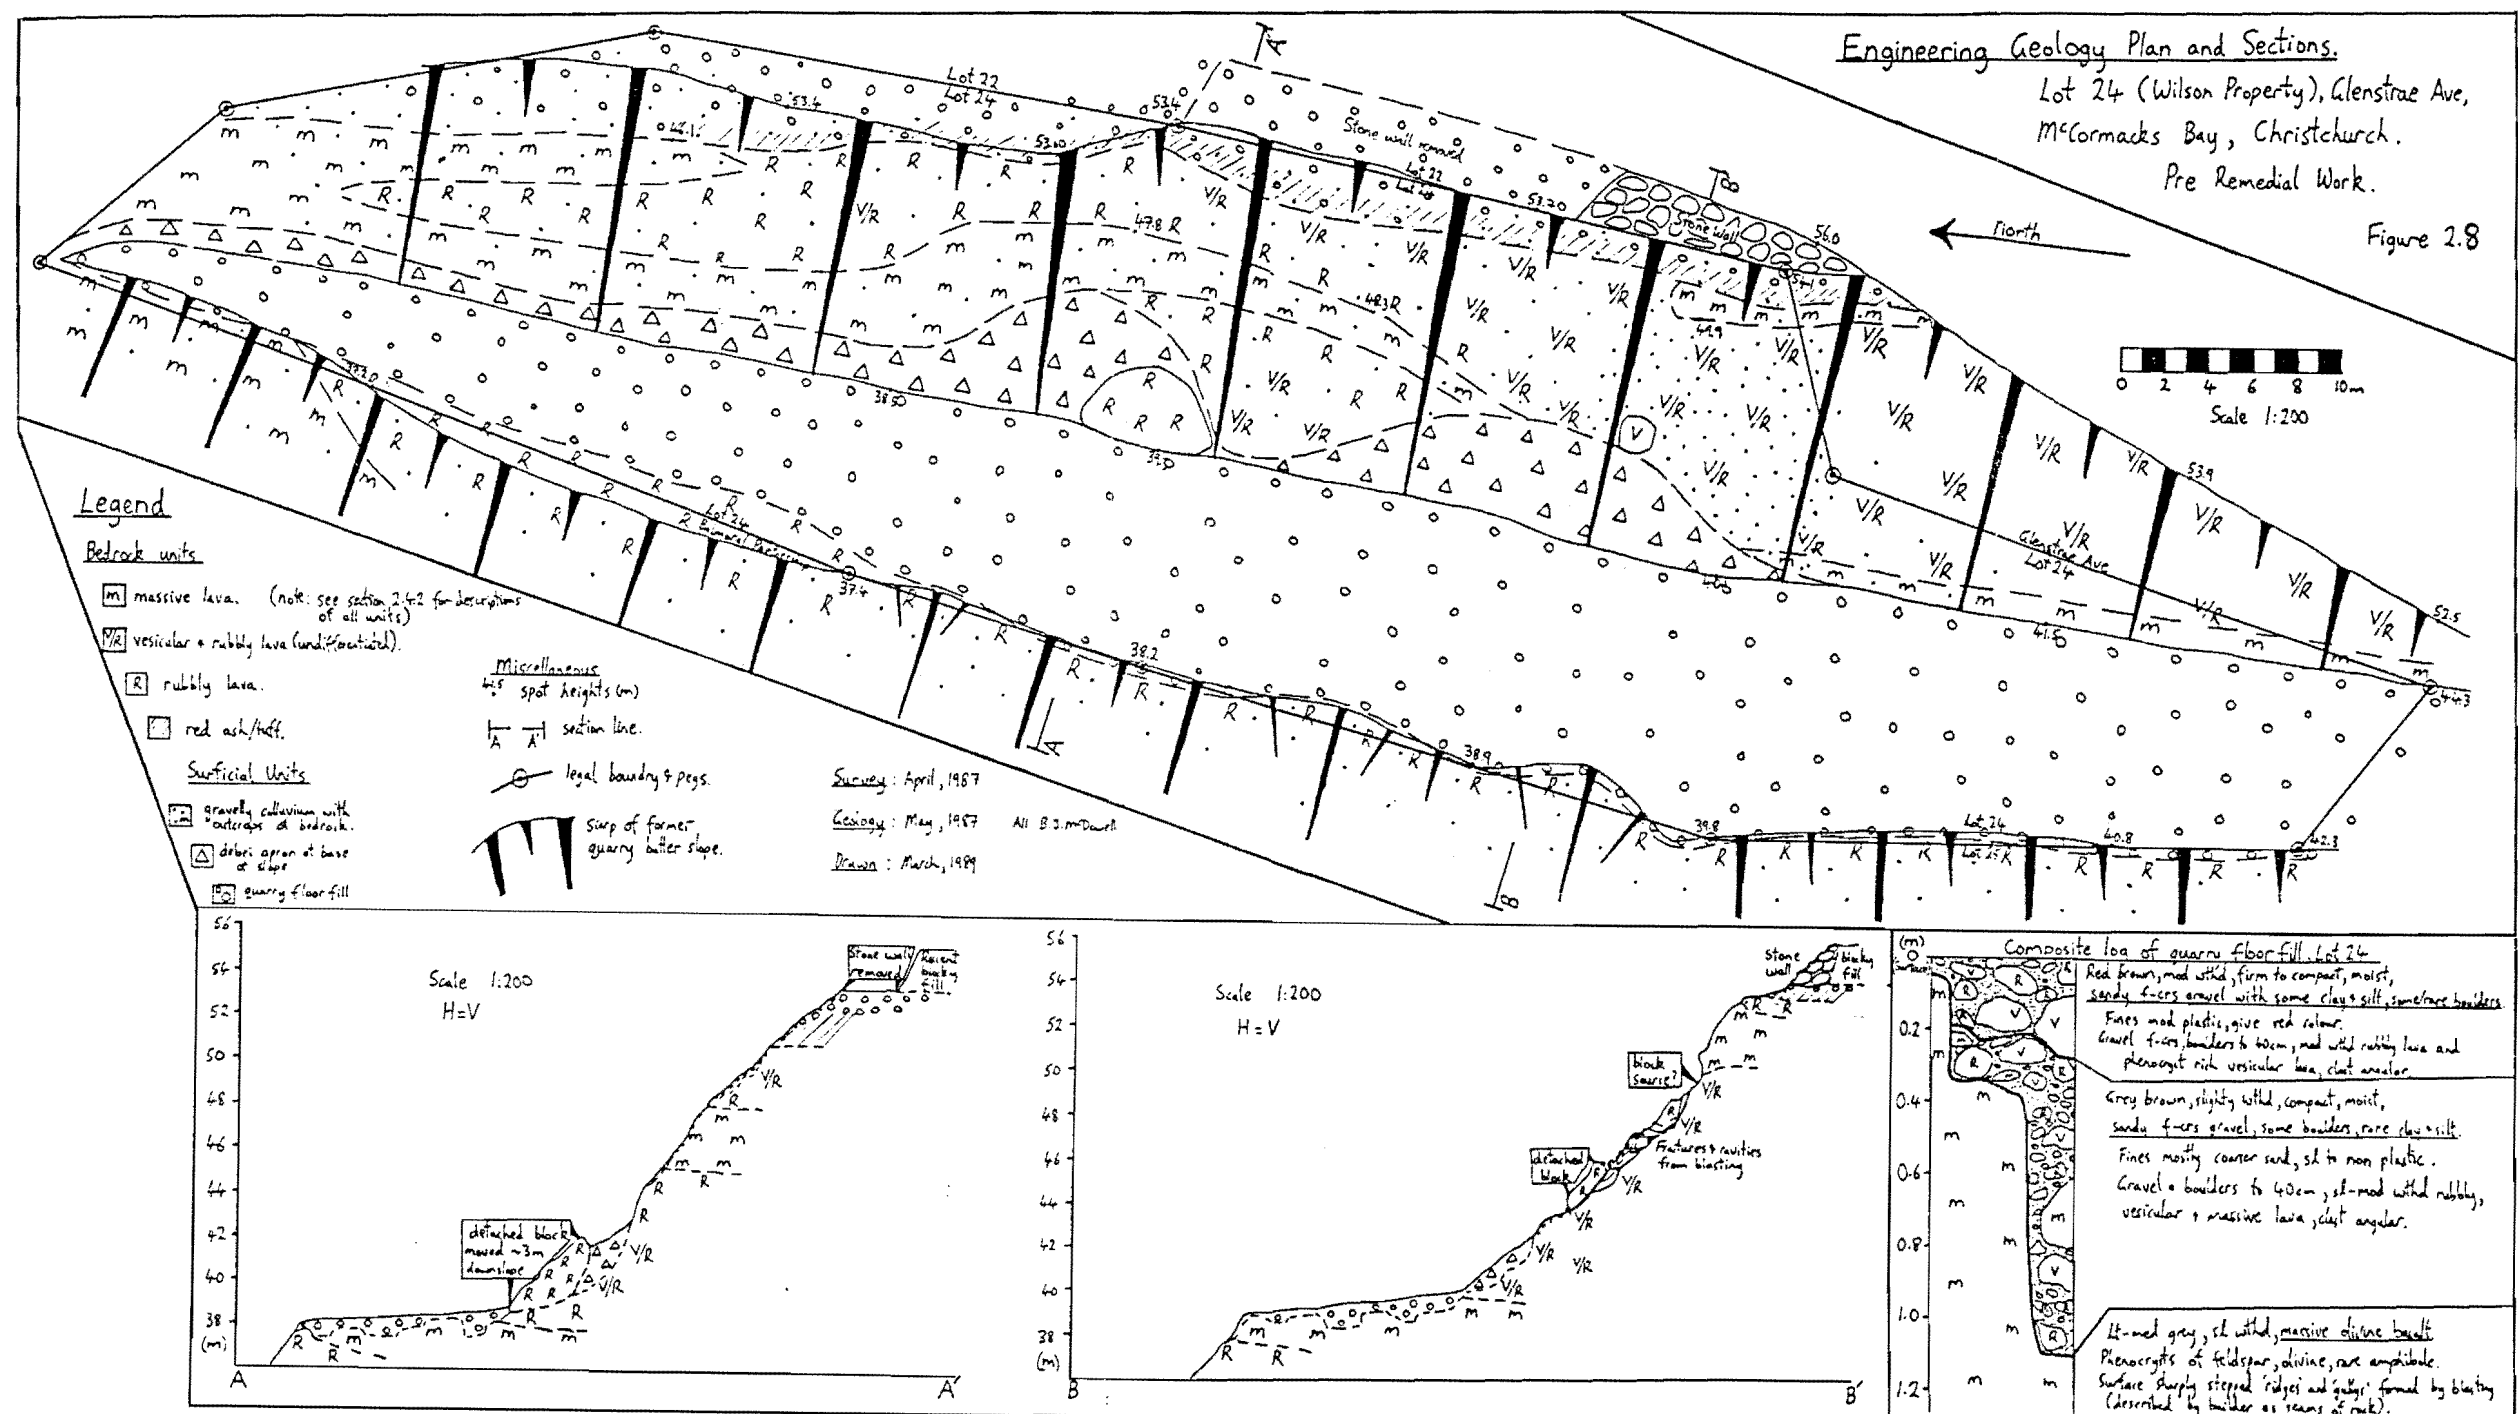
Figure 2.9 : Reduction of Pre Gabion Wall Plan and Sections

(4) May 1987: excavation of loose material continued on lot 5, with a backhoe accessing the higher slope by a ramp built from debris already pulled from the face (see Figure 2.9). A pocket of deeply fractured massive lava was uncovered and upto 10m^3 of material was being brought down with each stroke of the backhoe. Excavations were halted when they threatened to undermine the garden wall of the Wilson property above (see figure 2.14).

(6) February 1988: gabion wall erected. The wall was founded on benches cut in unfractured 'vesicular lava' (see figure 2.5). Some of the more precarious blocks on the scarp were pulled down using a backhoe and wire rope to make the site safe for excavation of the benches by jackhammer and light blasting. The baskets were placed, filled with cobbles, and the wall backfilled with gravel by a backhoe reaching from the fill ramp. Topsoil was placed, on the bench created above the gabion wall, to allow for the establishment of shrubs and groundcover vegetation. Figures 2.9 and 2.15 show pre- and post-gabion wall construction plans and sections over lots

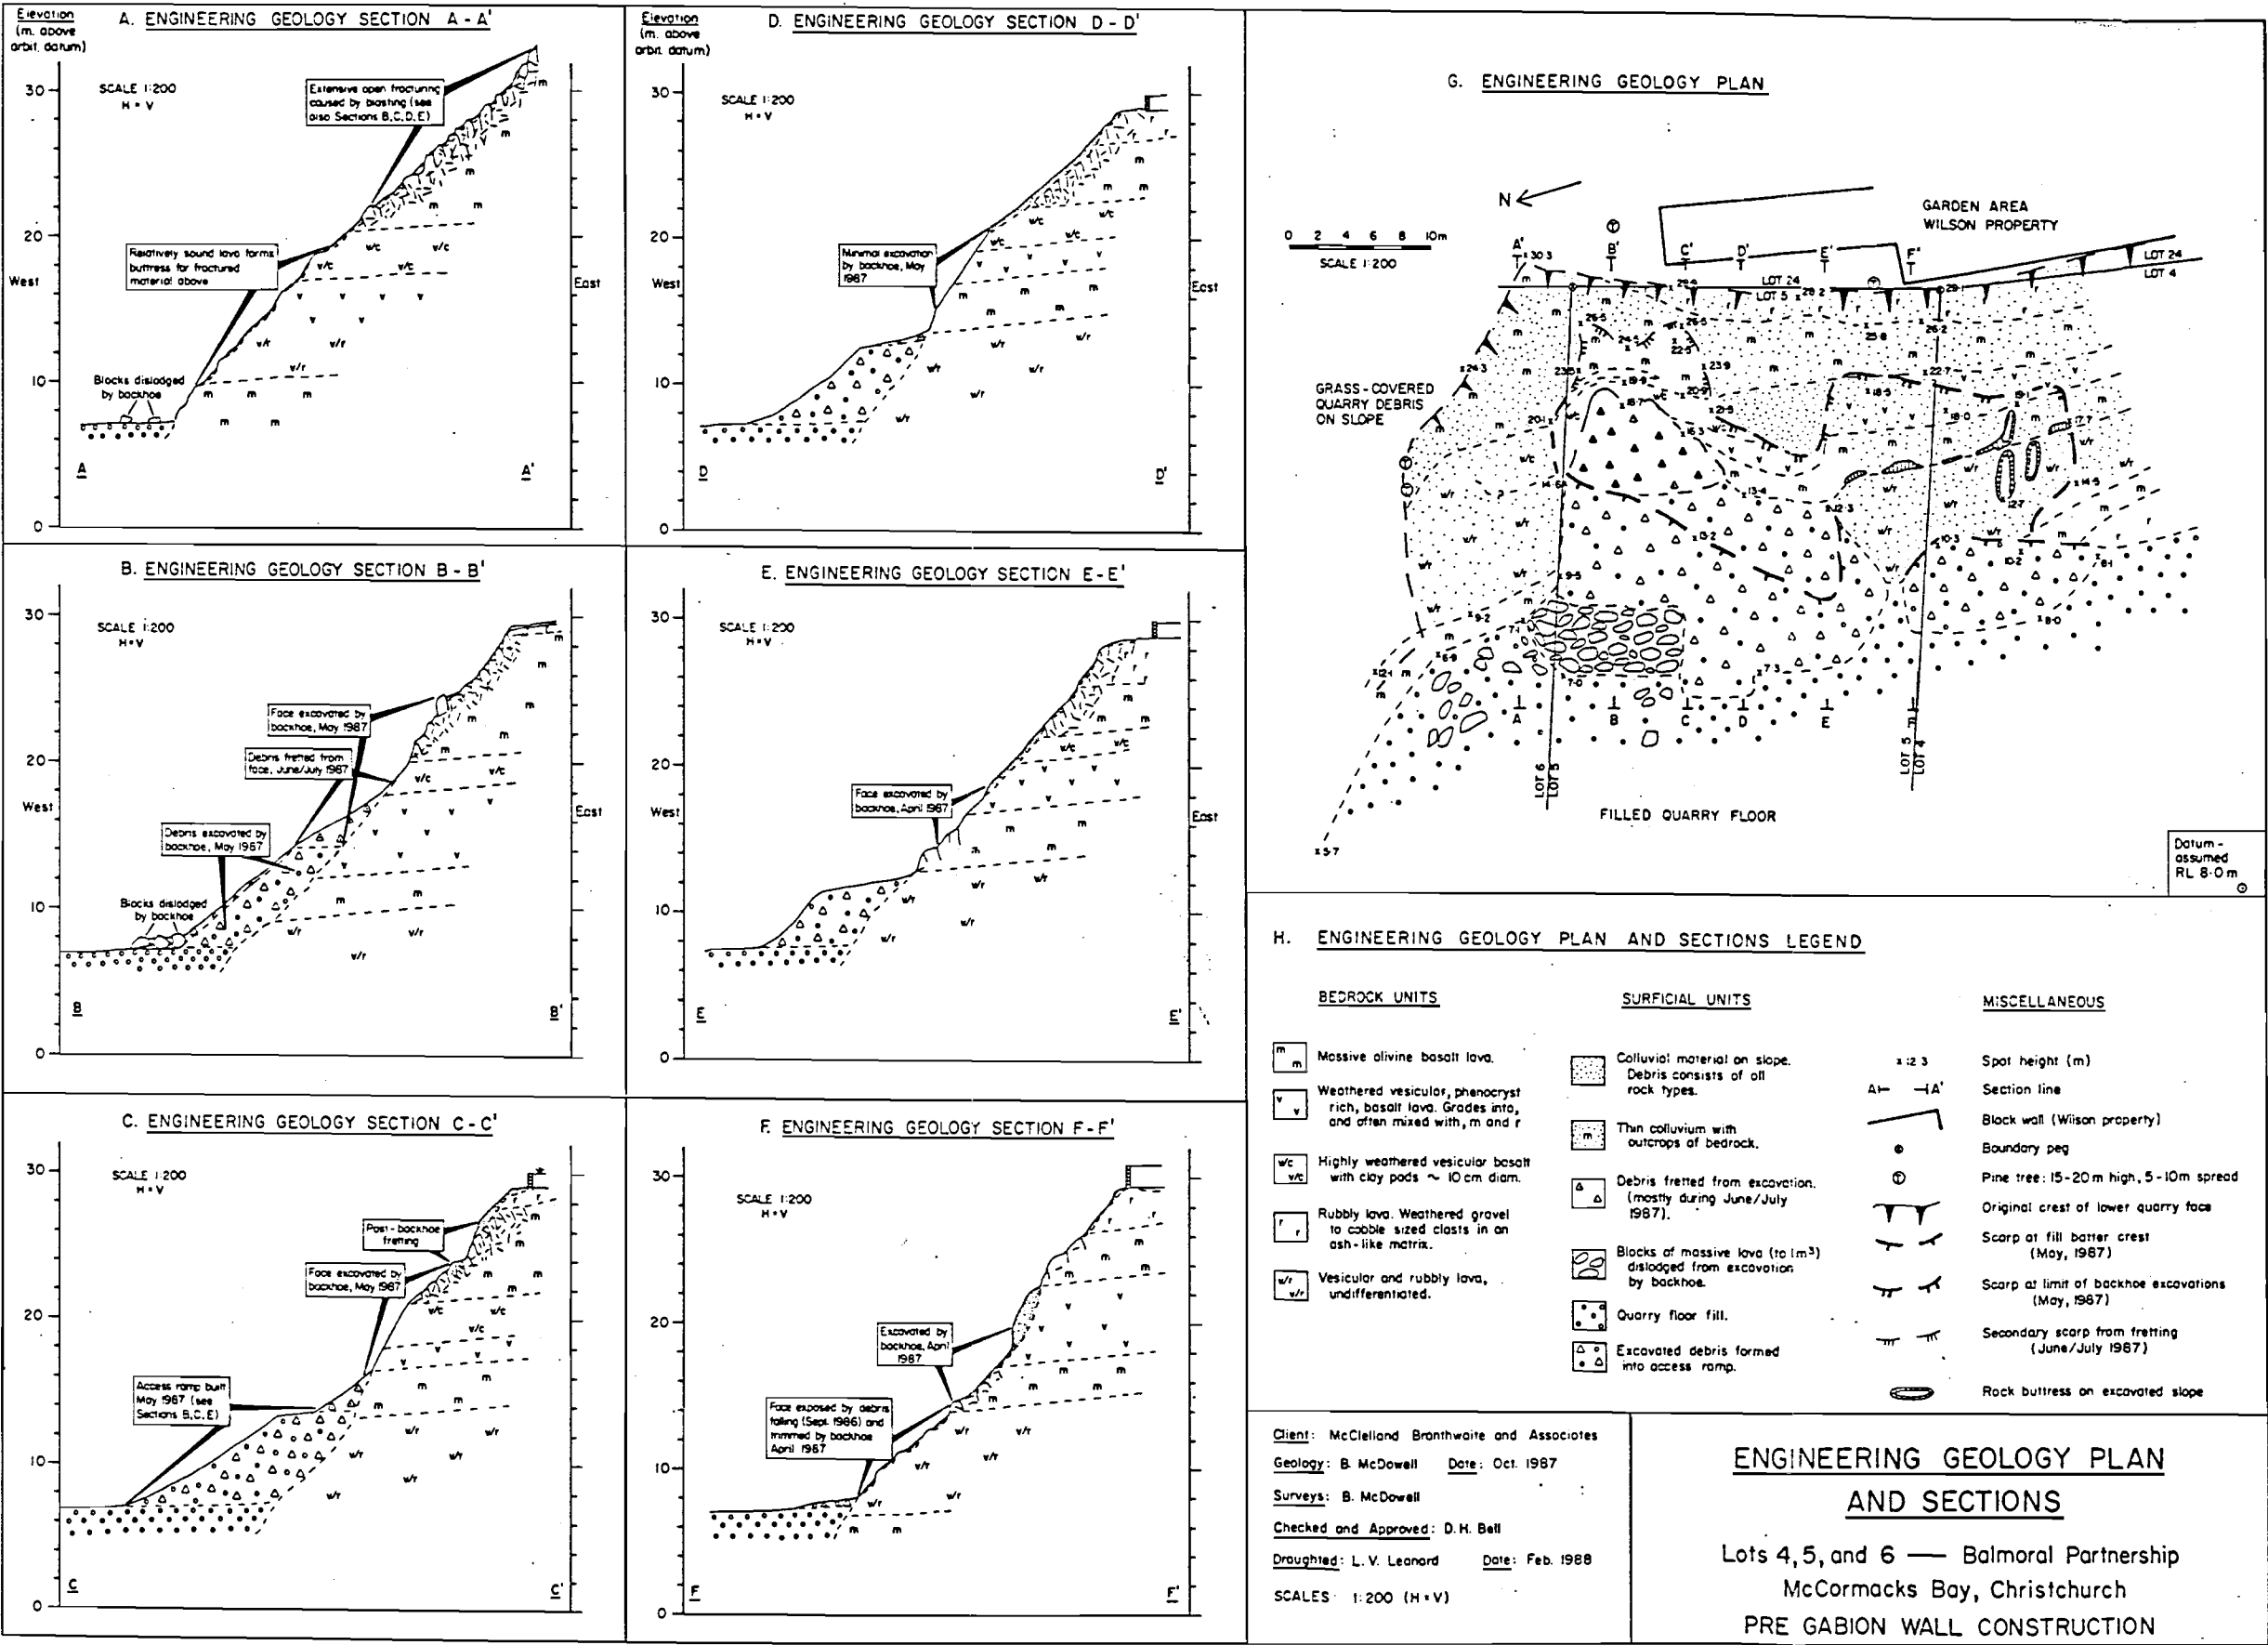
Figure 2.10 : Reduction of Balmoral Partnership Summary Sheet

Ash and lahar deposits will only reach significant thicknesses when preserved in major gully systems. They are restricted to the lower slope on lots 3 and 4 (Balmoral Partnership, see Figure 2.10), and to the boundary of lot 22 and 24 beneath the stone retaining wall (Figure 2.8).

(1) August 1986: uncemented ash and lahar layers exposed in the lower batter slope on lots 3 and 4 were trimmed by a backhoe (see figure 2.10).

(2) December 1986: a backhoe, with an I section steel girder extension, was used to "prod" down loose blocks and debris from around the original slope failure (see figure 2.13) and the potentially unstable area on lots 5 and 6 (see figure 2.10, section A-A'). The method was successful, but the backhoe could only reach about 1/3 of the batter slope and fractured loose material clearly continued higher onto the slope.

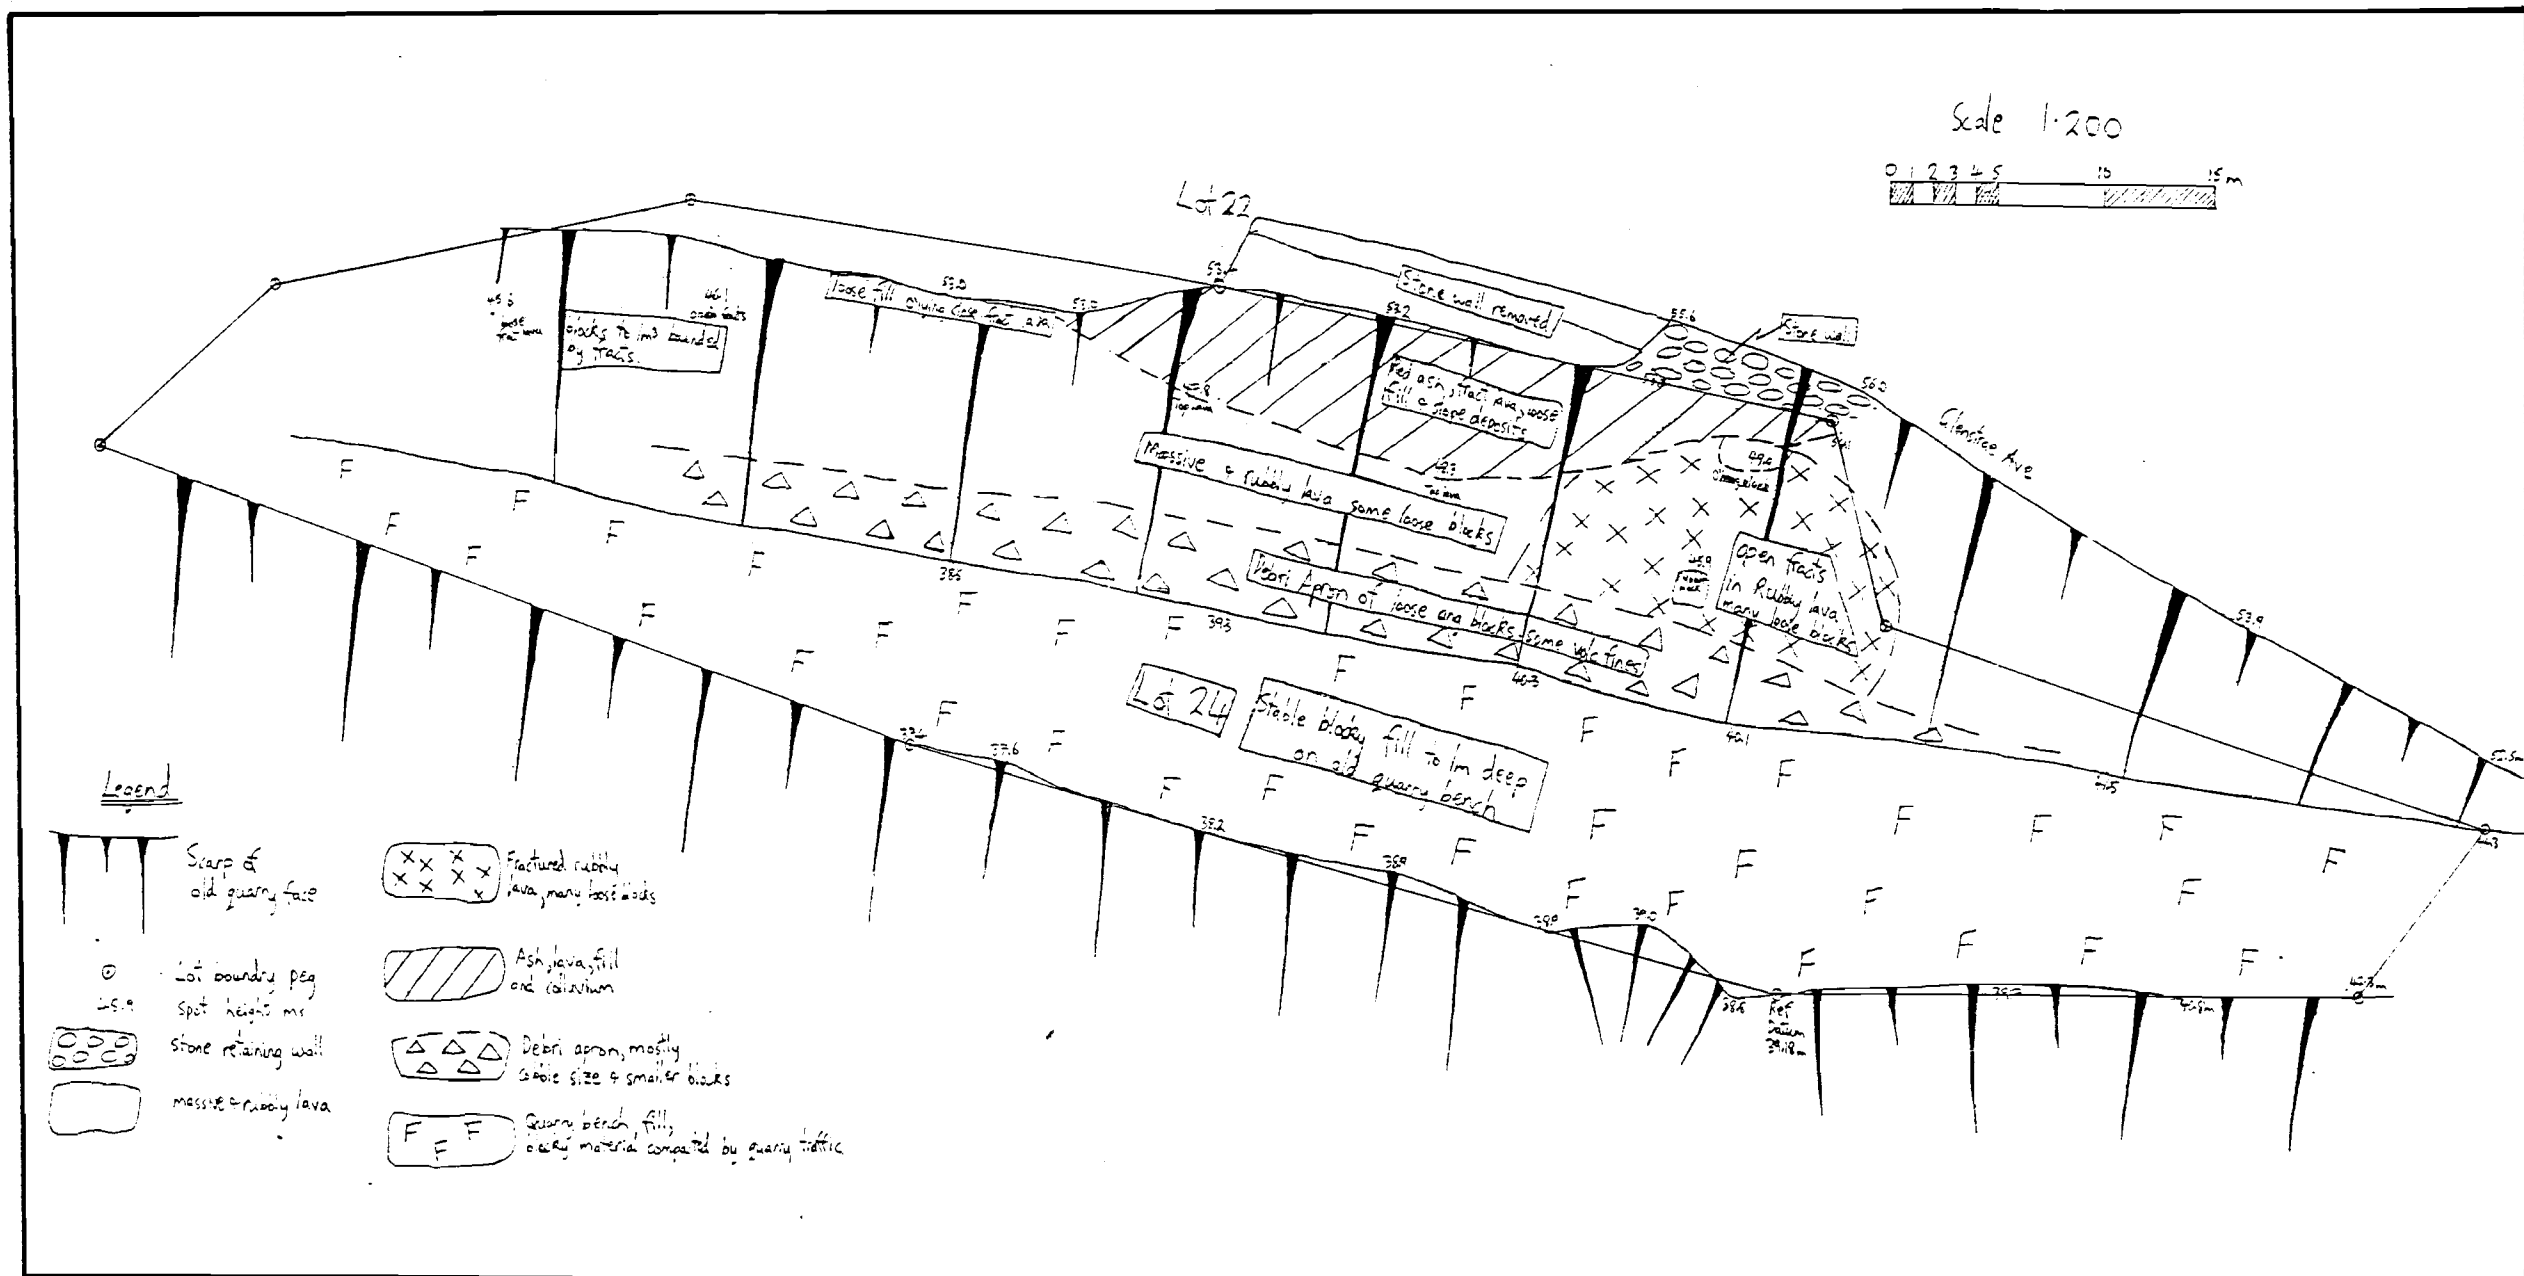
Figure 2.12 : Reduction of Original Working Plan for Lot 24
Site Investigations

limited stadia survey. A drafted plan and sections were not required by the consulting engineers, so a very simple pencil drafted plan (Figure 2.12) was drawn up to aid in the written recommendations.

The first inspection and walkover was sufficient to identify the major problems without resorting to more detailed mapping, or other investigation techniques (e.g. geophysics, trenching). Areas of concern can be divided into house foundations, upper slope and lower slope. The lower slope is the steep batter slope of Balmoral Partnership and was looked at from the point of view of a failure at the crest undermining the Wilson house foundations. It was recognised that slope failures in colluvium and fractured bedrock could cut back up to 2m from the present slope crest. Inspection of the foundation area revealed outcrops of massive and vesicular lava, with blocky fill not more than 1m deep, depending on the profile of the original quarry floor. Areas of loose fractured material and colluvial debris were identified on the upper slope, and a site meeting was held with engineer, builder and owner to discuss remedial measures across the upper slope.

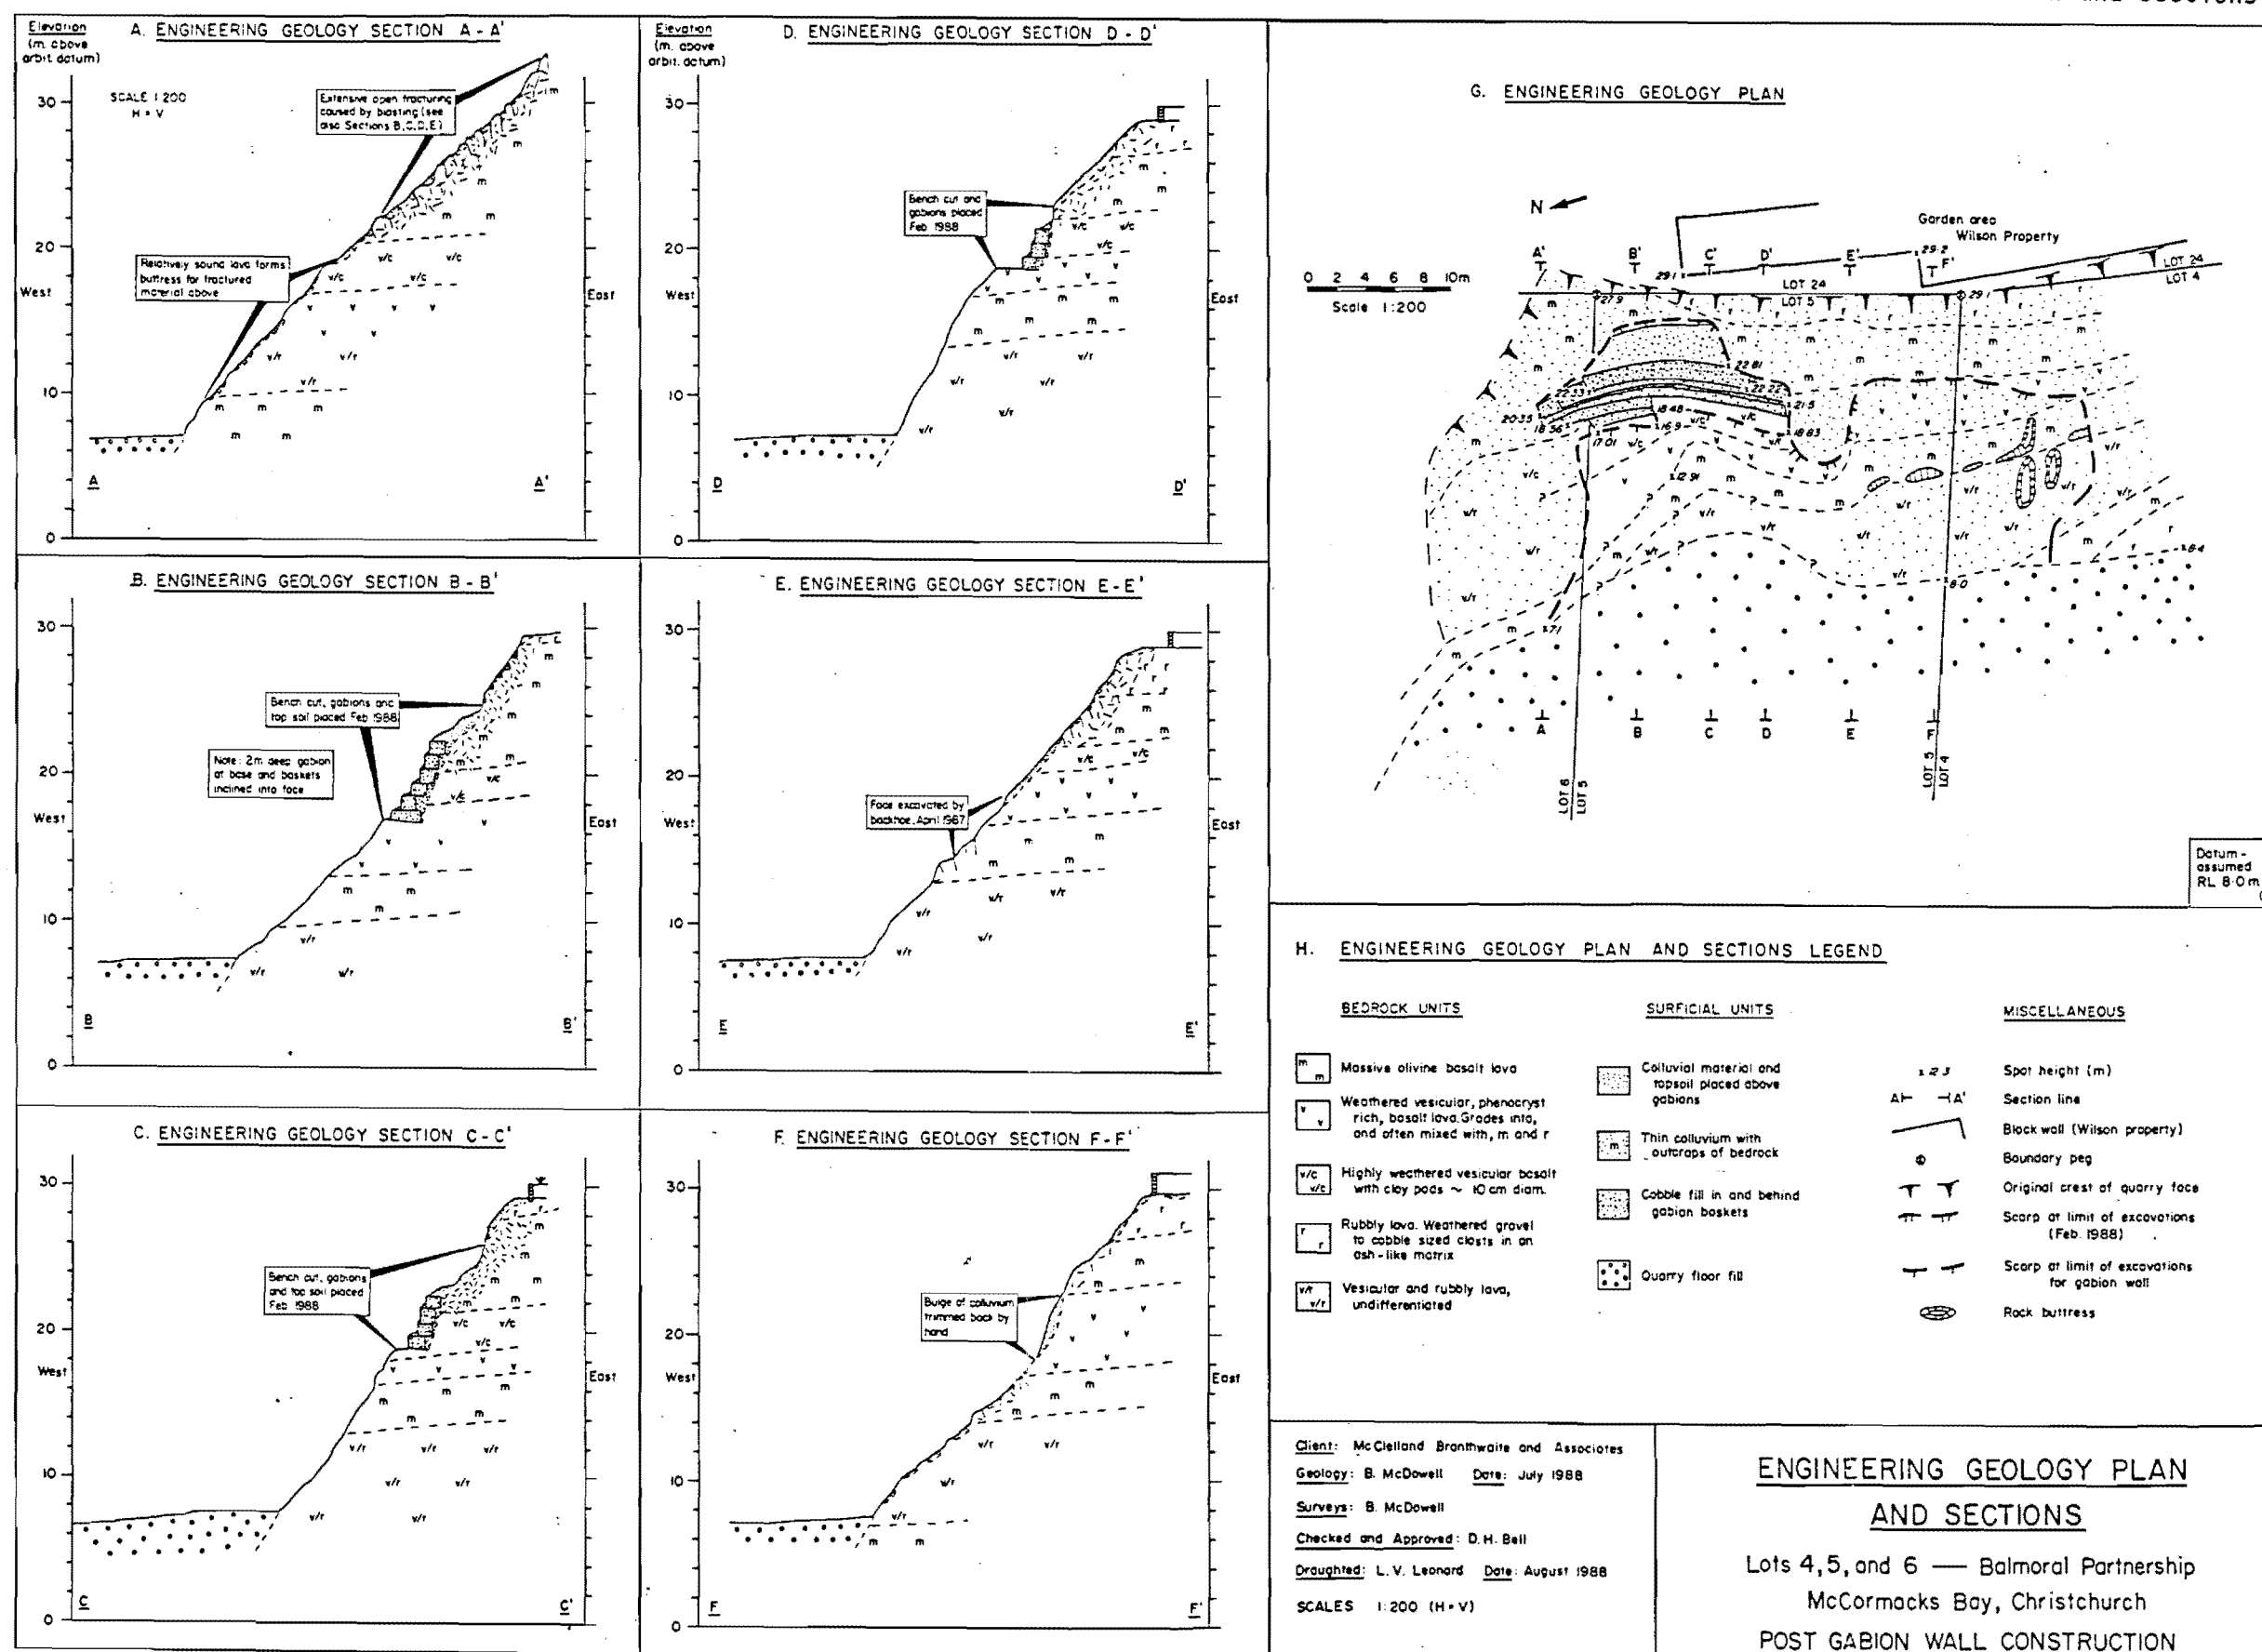
Figure 2.15 : Reduction of Post Gabion Wall Plan and Sections

The final fieldwork at this site involved re-surveying the lot 4,5,6 area after completion of the gabion wall and final tidying across the excavated area. A summary sheet similar to the preconstruction sheet was drawn up to allow direct comparisons between before and after construction profiles across the excavated area (Figure 2.15).

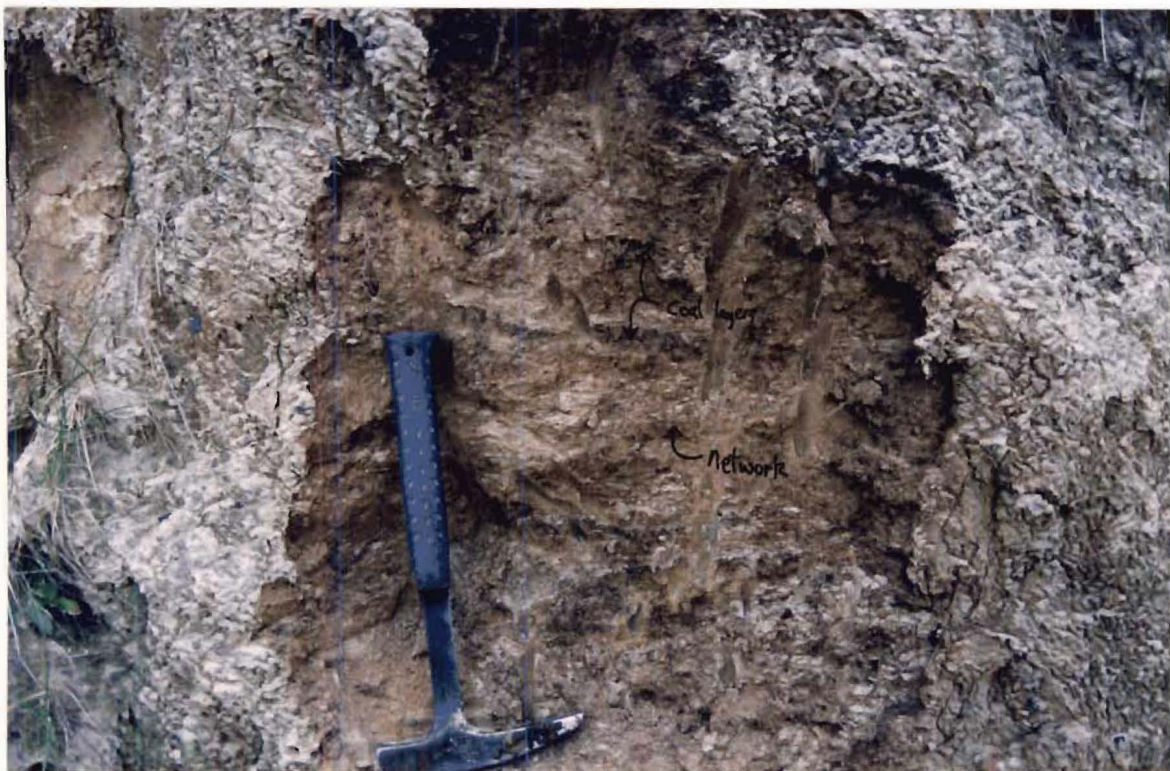
Figure 3.3 : Recent colluvium at the base of Coleridge Tce bank. Note network mottling and coal layers in cleared face, and slope wash silt lobes on surface

Evidence for the mode of formation of network mottling can be seen in deposits at the base of the Coleridge Tce bank. Figure 3.3 shows network structure in unconsolidated material that includes layers of coal, clinker and rusted iron fragments, indicating the material is recent colluvium and slope wash. Figure 3.3 also shows the formation of network mottling, with slope wash forming small lobes, or lenses of silt that may be draped with clayey loess and organic rich soil. Repetition of the slope wash/draping sequence builds up a network mottled deposit. The gradation from network mottled yellow grey silt to brown grey silt is controlled by the increasing dominance of draping/soil forming processes over slope wash processes, along with increasing amounts of bioturbation.

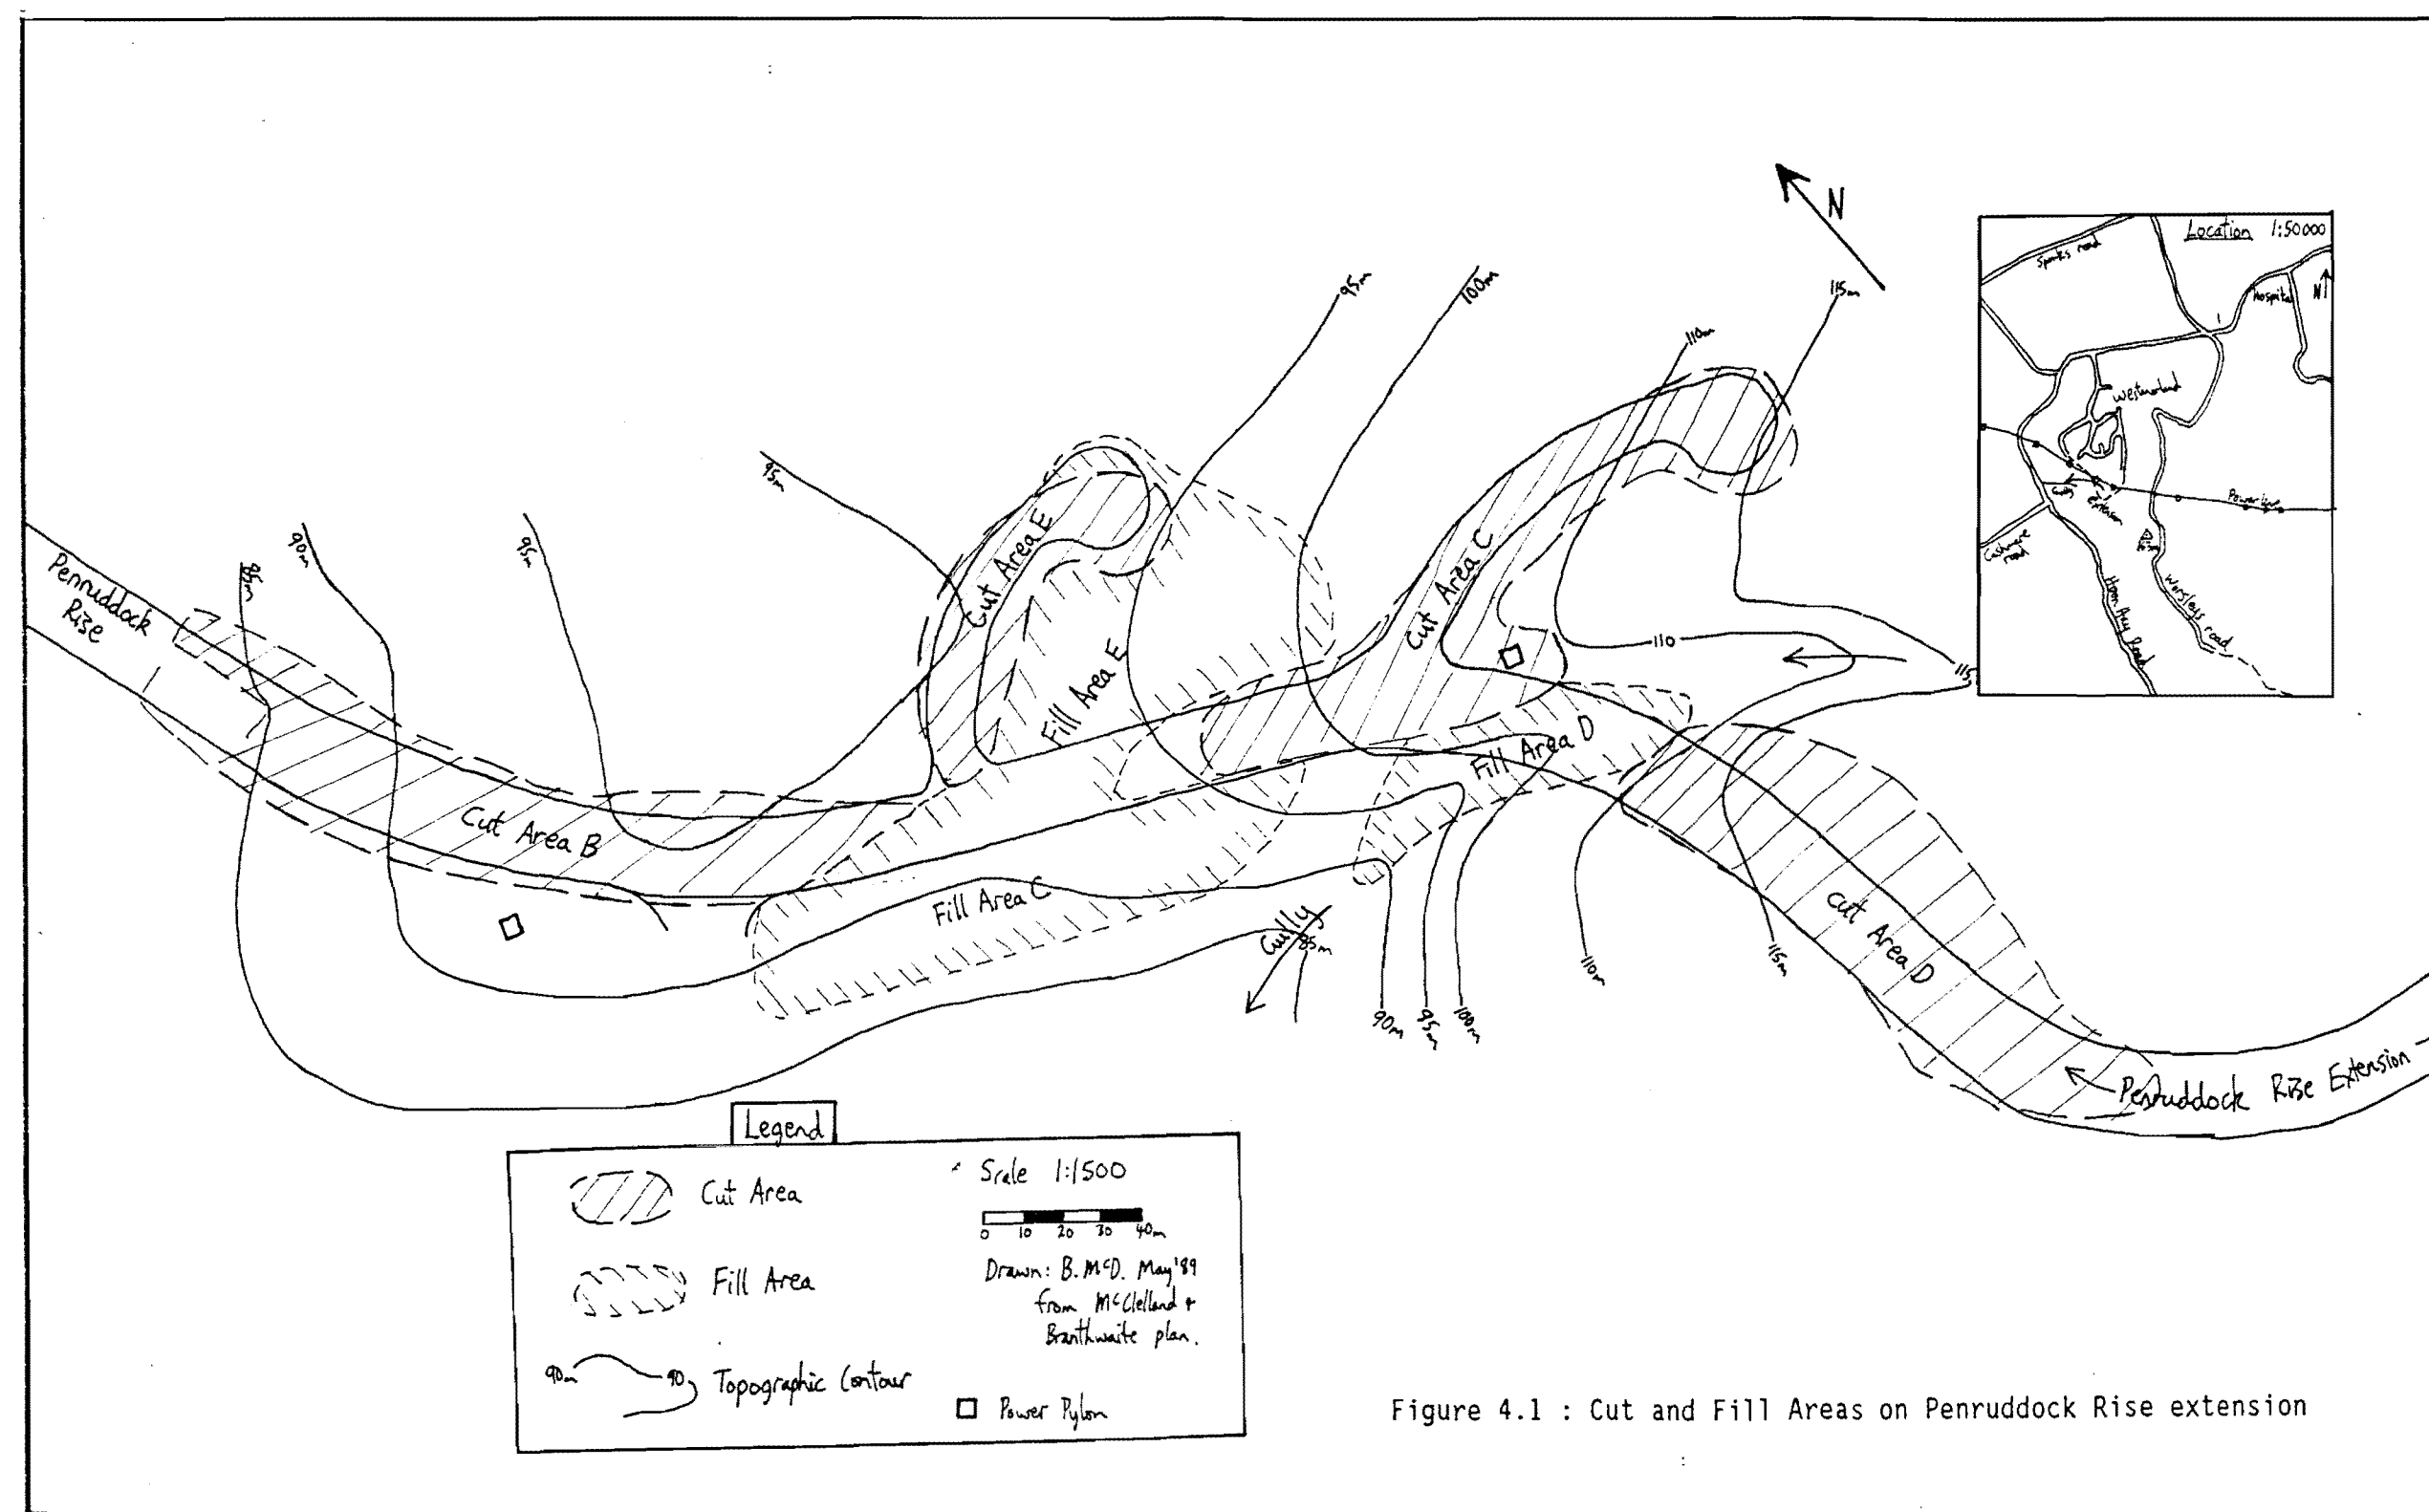
Figure 4.1 : Cut and Fill Areas on Penruddock Rise extension

The Penruddock Rise extension of Westmorland subdivision is located on the southern edge of a gently to moderately sloping (5-20⁰) loess draped basalt spur above the existing development (Figures 4.1, 4.2 and 4.3). Proposals for development involved two areas of cut and two areas of fill along the road alignment. The maximum planned cut depth was 8m, with a maximum fill depth of 6m in a steep sided gully that dissects the loess mantle on the West side of Westmorland spur (Figures 4.1, 4.2, 4.3). The author was involved in preliminary site investigations followed by monitoring and documentation of the cut and fill operations. Engineering geology mapping along with some seismic refraction profiles and backhoe test pits were used to confirm the feasibility of the proposed road alignment and cut and fill operations.

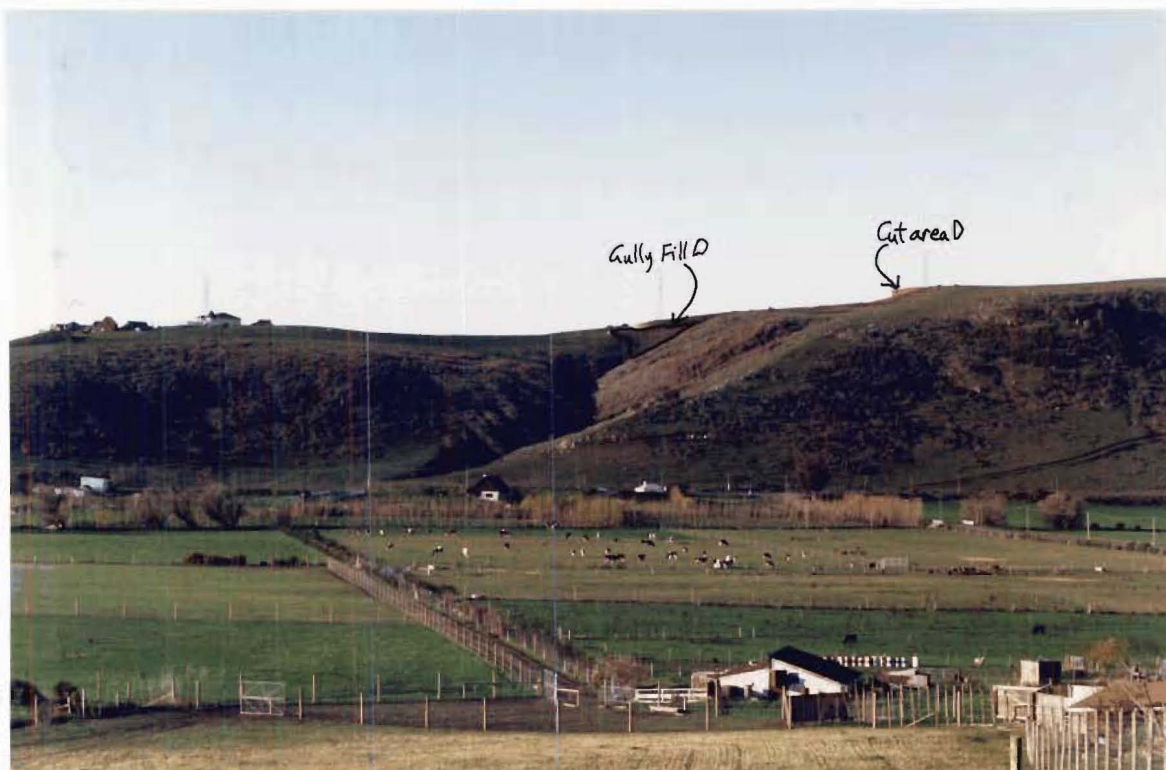
Figure 4.2 : View of SW side of Westmorland Spur. Note Gully and Gully Fill

Refer to figure 4.4 (engineering geological map and sections) during the following description of geology and geomorphology. A NW dipping stack of basaltic lava flows (Lyttleton Group volcanics) is exposed on the steep SW bounding face of Westmorland spur (see figure 4.2). Thin (maximum of 3m) discontinuous sheets of mixed colluvium and loess colluvium obscure bedrock on the face.

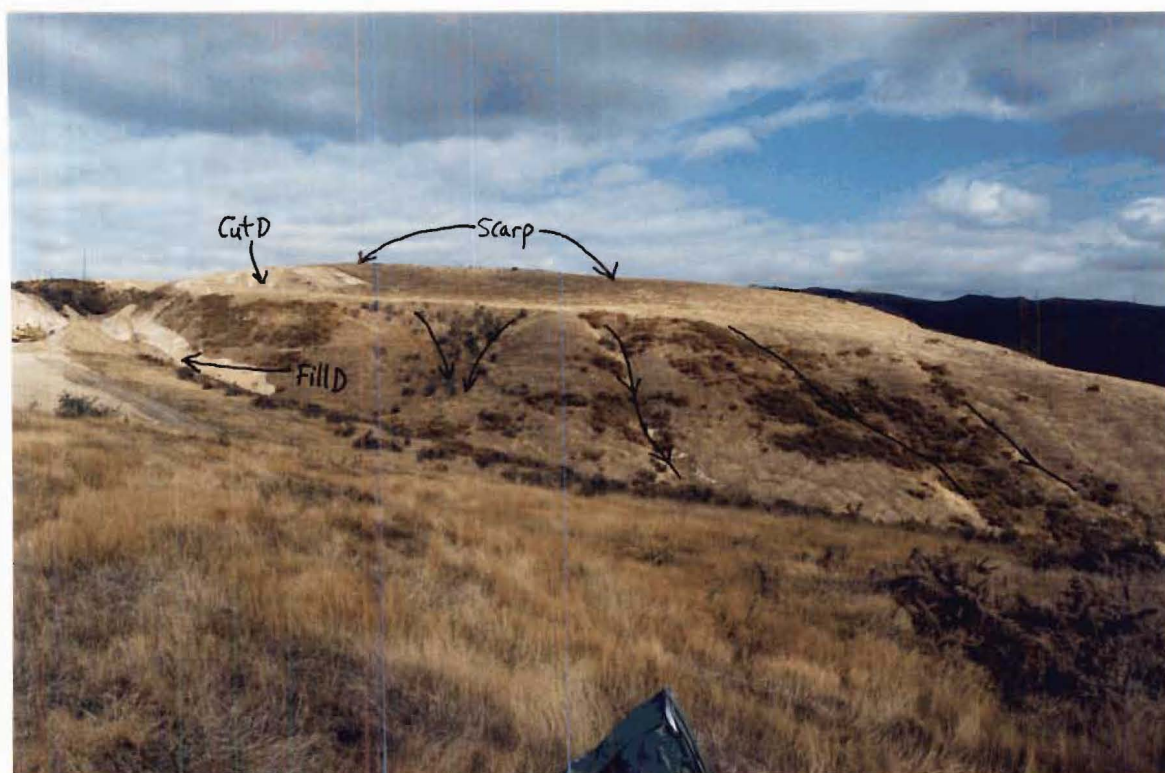
Figure 4.3 : View Across Gully to Cut Area D and large Inactive Landslide Scarp (arrowed). Note fill area D and gullys in loess colluvium (arrowed)

Numerous small inactive slide/flow failures are expressed on the gentle to moderate slopes W-SW of the road alignment by 0.5-1m high scarplets and degraded debris lobes (approximately 5-10m³). Scarplets are superimposed on a large arcuate scarp that is traversed by the road extension and cut area D (see figures 4.1, 4.3 and 4.4). This large scarp has the form of a slope failure, but the morphology of the face has been modified by superimposed small failures, and there is no obvious toe deposit. The area that could be occupied by toe debris is a gently sloping surface with a subdued hummocky topography (maximum relief 0.5m). Toe deposits could have been reworked over the edge of the lower gully, as loess colluvium over bedrock is thickest along this section of the gully flank.

There are 2 options for the origin of the large scarp: (a) a large slope failure in thick loess, or (b) a natural depositional feature. If the scarp was a depositional feature the upper fragipan would follow the contour of the slope, however excavations across cut area D showed that the upper fragipan and underlying buried soils (see figure 4.5) are almost flat lying and truncated by the scarp. The body of this evidence indicates a large slope failure (possibly related to erosion of loess infilling the pre-existing bedrock gully) that occurred after development of the upper

(3) Cut area D crosses the degraded head scarp of a large inactive slope failure. Loess thickness at this point is approximately 18m - cut depth 8m.
